TRANSPORTATION ELEMENT TECHNICAL PAPER

This chapter includes a brief review of the existing transportation network in the Town of Blandford. Major routes were identified in order to identify travel patterns throughout the Town. All sidewalks in Town were inventoried to identify gaps in the existing pedestrian system. This chapter also provides an outlook of the existing safety concerns and takes into consideration public input provided during the master plan survey process, Visioning Session and Focus Groups to shape goals and strategies that improve future transportation conditions in the Town of Blandford.

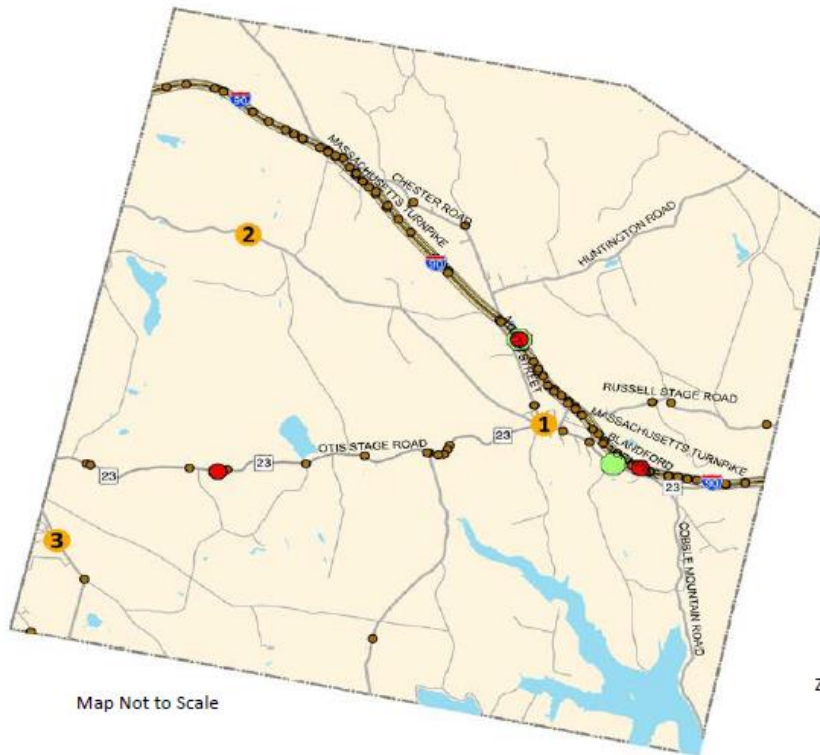
Pioneer Valley SafetyCompass (2015-2017)

- Fatal Crashes
- Intersection Crashes
- Non Motorist Crashes
- All Crashes (2015-2017)
- Open Water Bodies

A total of five crashes were identified to have occurred on a curved section of Otis Stage Road (Route 23) just east of Beach Hill Road. All five crashes involved a single vehicle lane departure crash, one of the crashes resulted in a second vehicle being side swiped. It is recommended that a more in depth study be considered for this section of Otis Stage Road to identify potential contributing factors to single vehicle crashes in this area.

Four intersection crashes were reported in Blandford (all property damage only) within the analysis period. Three of those crashes were geocoded. The locations of those crashes are depicted in the map and listed below:

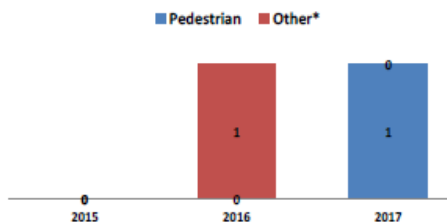
Non-motorist Crashes by Type and Year

* Skater, wheelchair, unicycle, tricycle, etc.
